CHAPTER 13 – GEOTECHNICAL

13. Geotechnical and Materials Management

- 13.1.1. This chapter reports on the existing soil, surface water and groundwater chemical conditions on site and the engineering properties of the ground in relation to development of Buttington Energy Recovery Facility ("ERF").

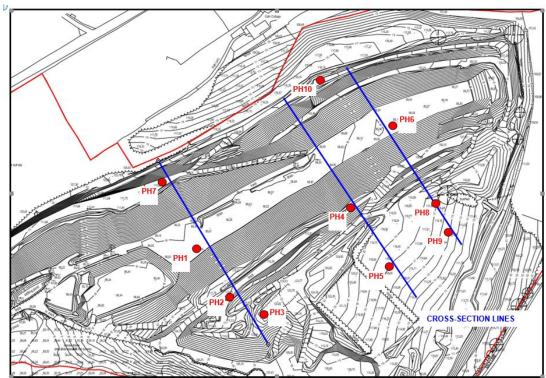
- 13.3.19. The geological and ground conditions across the Development Area were determined through study of available geological maps, a field survey of the exposed geology within the sides of the quarry void and through intrusive site investigation comprising ten rotary probeholes (PH1 PH10) which retrieved cores of the various rock formations. The findings are described in detail in the Geo-environmental and Geotechnical Assessment Site Investigation Report, see Technical Appendix 13-1.
- 13.3.20. Probehole Locations are provided on Figure 13-3.

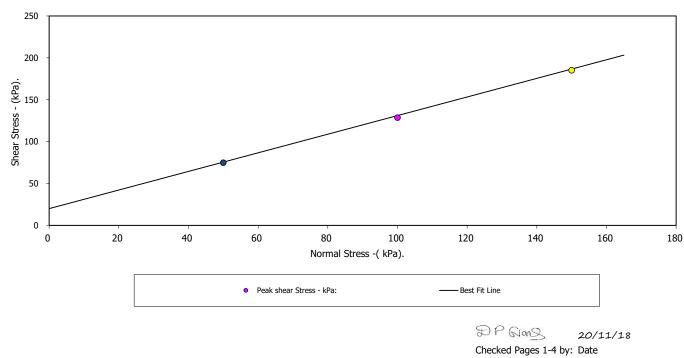
Borehole Number:	S1	Depth from (m):	0.00	
Sample Number :	1	Depth to (m):	0.00	
Sample Type:	В	· · · ·		
Particle Density - Mg/m3:		2.65 (Assumed)	
Specimen Tested:	At natural m	noisture content, Remoulded (Light	Tamping) Material above 20	mm removed.
Sample Description:				
Brown clayey fine to medium GRAVE	L			
STAGE		1	2	3
Initial Conditions				
Height - mm:		136.00	136.00	136.00
Length - mm:		300.00	300.00	300.00
Moisture Content - %:		10	10	10
Bulk Density - Mg/m3:		2.04	2.04	2.04
Dry Density - Mg/m3:		1.85	1.85	1.85
Voids Ratio:		0.4316	0.4317	0.4318
Normal Pressure- kPa		50	100	150
Consolidation				
Consolidated Height - mm:		133.03	131.54	129.77
Shear				
Rate of Strain (mm/min)		0.66	7 0.667	0.667
Strain at peak shear stress (%)		58.55	60.41	63.30
Peak shear Stress - kPa:		75	129	185
РЕАК				
Angle of Shearing Resistance:(0)				48.0
Effective Cohesion - kPa:				20

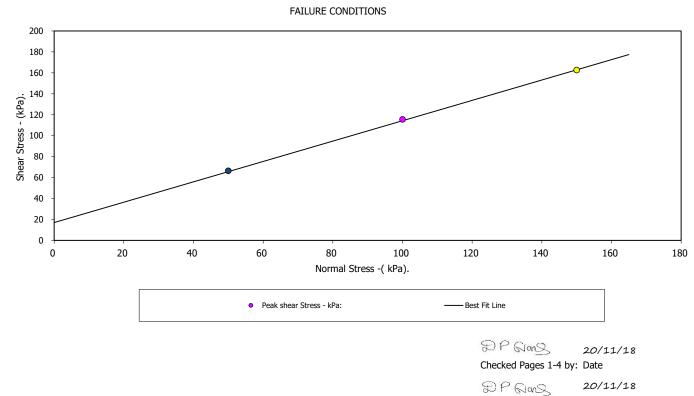
Borehole Number:	S2	Depth from (m):	0.00	
Sample Number :	2	Depth to (m):	0.00	
Sample Type:	В			
Particle Density - Mg/m3:		2.65 (Assume	d)	
Specimen Tested:	At natural n	noisture content, Remoulded (Ligl	nt Tamping) Material above 2	20mm removed.
Sample Description:				
Brown clayey fine to medium GRAVEL				
STAGE		1	2	3
Initial Conditions				
Height - mm:		130.0	0 130.00	130.00
Length - mm:		300.0	0 300.00	300.00
Moisture Content - %:		1	0 10	10
Bulk Density - Mg/m3:		2.0	2 2.02	2.02
Dry Density - Mg/m3:		1.8	3 1.83	1.83
Voids Ratio:		0.447	8 0.4478	0.4477
Normal Pressure- kPa		5	0 100	150
Consolidation				
Consolidated Height - mm:		126.4	0 121.96	117.52
Shear				
Rate of Strain (mm/min)		0.6	67 0.667	0.667
Strain at peak shear stress (%)		55.0	6 55.19	57.32
Peak shear Stress - kPa:		6	6 116	163
PEAK				
Angle of Shearing Resistance:(0)				44.2
Effective Cohesion - kPa:	·			17

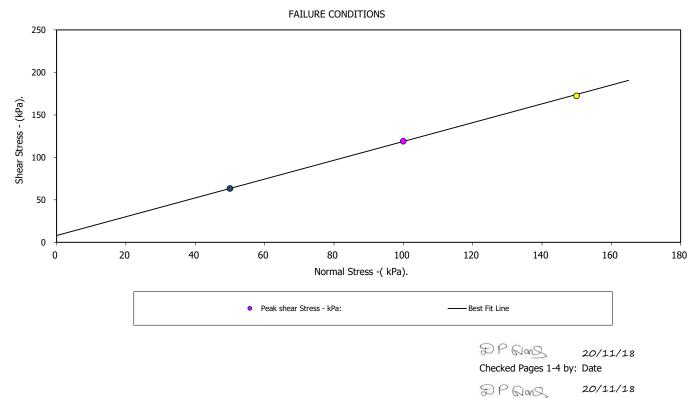
Borehole Number:	S3	Depth from (m):	0.00	
Sample Number :	3	Depth to (m):	0.00	
Sample Type:	В			
Particle Density - Mg/m3:		2.65 (Assumed)		
Specimen Tested:	At natural mo	pisture content, Remoulded (Light	Tamping) Material above 20n	nm removed.
Sample Description:				
Brown slightly clayey fine to mediur	n GRAVEL			
STAGE		1	2	3
Initial Conditions				
Height - mm:		134.00	134.00	134.00
Length - mm:		300.00	300.00	300.00
Moisture Content - %:		7	7	7
Bulk Density - Mg/m3:		1.62	1.62	1.62
Dry Density - Mg/m3:		1.52	1.52	1.52
Voids Ratio:		0.7425	0.7426	0.7427
Normal Pressure- kPa		50	100	150
Consolidation				
Consolidated Height - mm:		129.93	127.63	125.80
Shear				
Rate of Strain (mm/min)		0.667	0.667	0.667
Strain at peak shear stress (%)		54.10	65.71	66.42
Peak shear Stress - kPa:		63	119	173
PEAK				
Angle of Shearing Resistance:(0)				47.9
Effective Cohesion - kPa:				8

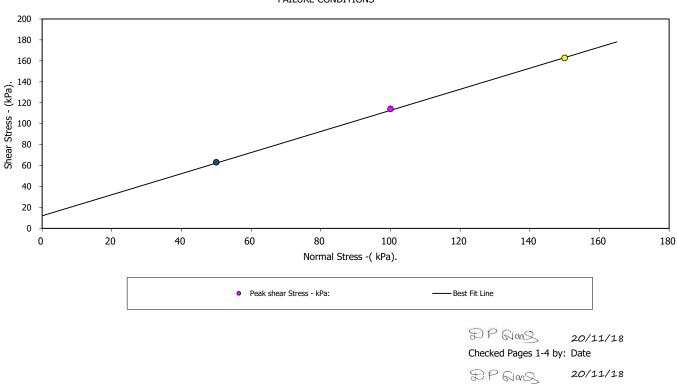
Borehole Number:	S4	Depth from (m):	0.00	
Sample Number :	4	Depth to (m):	0.00	
Sample Type:	В			
Particle Density - Mg/m3:		2.65 (Assumed)	
Specimen Tested:	At natural m	oisture content, Remoulded (Light	Tamping) Material above 20r	nm removed.
Sample Description:				
Brown slightly clayey fine to mediun	n GRAVEL			
STAGE		1	2	3
Initial Conditions				
Height - mm:		134.00	134.00	134.00
Length - mm:		300.00	300.00	300.00
Moisture Content - %:		12	12	12
Bulk Density - Mg/m3:		1.59	1.59	1.59
Dry Density - Mg/m3:		1.43	1.43	1.43
Voids Ratio:		0.8575	0.8577	0.8575
Normal Pressure- kPa		50	100	150
Consolidation				
Consolidated Height - mm:		130.29	129.03	127.07
Shear				
Rate of Strain (mm/min)		0.667	0.667	0.667
Strain at peak shear stress (%)		53.12	52.66	56.20
Peak shear Stress - kPa:		63	114	163
РЕАК				
Angle of Shearing Resistance:(0)				45.2
Effective Cohesion - kPa:				12

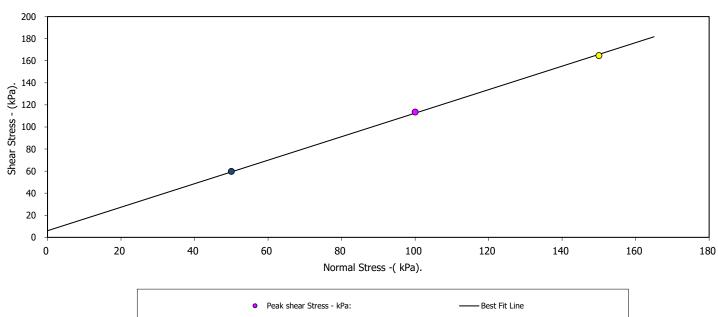
Borehole Number:	S5	Depth from (m):	0.00	
Sample Number :	5	,	0.00	
Sample Type:	В			
Particle Density - Mg/m3:		2.65 (Assumed)		
Specimen Tested:	At natural m	noisture content, Remoulded (Light T	amping) Material above 20m	im removed.
Sample Description:				
Brown slightly clayey fine to mediun	າ GRAVEL			
STAGE		1	2	3
Initial Conditions				
Height - mm:		132.50	132.50	132.50
Length - mm:		300.00	300.00	300.00
Moisture Content - %:		6	6	6
Bulk Density - Mg/m3:		1.65	1.65	1.65
Dry Density - Mg/m3:		1.55	1.55	1.55
Voids Ratio:		0.7053	0.7049	0.7050
Normal Pressure- kPa		50	100	150
Consolidation				
Consolidated Height - mm:		128.00	126.20	124.88
Shear				
Rate of Strain (mm/min)		0.667	0.667	0.667
Strain at peak shear stress (%)		60.01	61.02	61.02
Peak shear Stress - kPa:		60	113	165
PEAK				
Angle of Shearing Resistance:(θ)				46.8
Effective Cohesion - kPa:				6

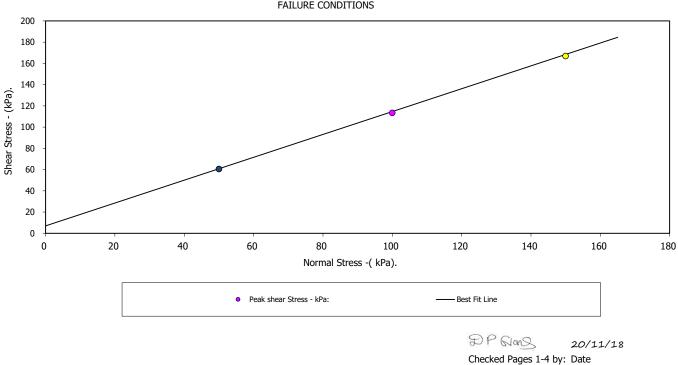
Borehole Number:	S6	Depth from (m):	0.00	
Sample Number :	6	Depth to (m):	0.00	
Sample Type:	В			
Particle Density - Mg/m3:		2.65 (Assume	d)	
Specimen Tested:	At natural m	oisture content, Remoulded (Ligh	t Tamping) Material above 2	20mm removed.
Sample Description:				
Brown slightly clayey fine to medium	GRAVEL			
STAGE		1	2	3
Initial Conditions				
Height - mm:		135.0	0 135.00	135.00
Length - mm:		300.0	0 300.00	300.00
Moisture Content - %:		1	0 10	10
Bulk Density - Mg/m3:		1.6	0 1.60	1.60
Dry Density - Mg/m3:		1.4	4 1.44	1.44
Voids Ratio:		0.835	3 0.8351	0.8355
Normal Pressure- kPa		5	0 100	150
Consolidation				
Consolidated Height - mm:		132.2	2 129.72	128.51
Shear				
Rate of Strain (mm/min)		0.66	67 0.667	0.667
Strain at peak shear stress (%)		66.1	4 67.37	57.68
Peak shear Stress - kPa:		6	1 113	167
PEAK				
Angle of Shearing Resistance: (θ)				47.1
Effective Cohesion - kPa:				7

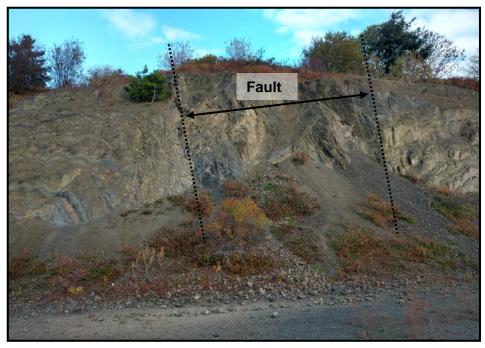
Several faults are documented to be present. The western most fault shown in **Figure 3.1** was confirmed in the north-western face of the quarry.

Figure 4.2: Fault line as seen in upper north-western quarry face

The two sides of this fault may be seen on **Drawing 01**.

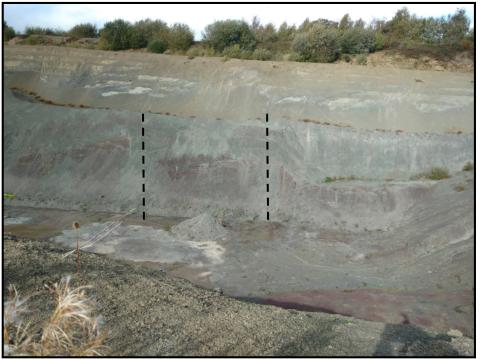
- 13.3.25. The geological map of the area records superficial Devensian fluvioglacial fan deposits (sand and gravel) or Devensian till in the immediate areas surrounding the quarry top but cover was found to comprise weathered bedrock deposits.

Several small unmapped faults may also be clearly observed in the lower northeastern end of the north-western quarry face, down-throwing strata towards the northeast, see **Figure 4.3**.

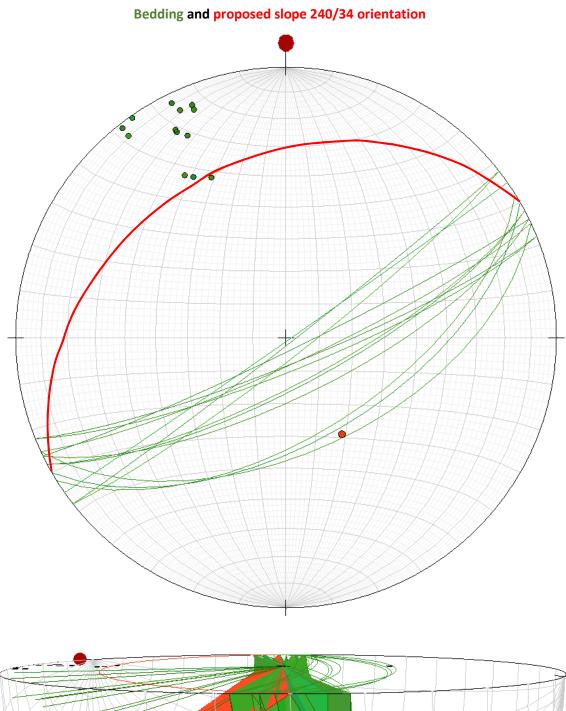
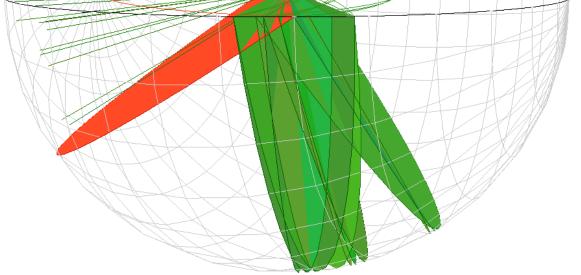
SLOPE CUT AT 240/34

Fractures and proposed slope 240/34 orientation

13.3.66. Slope stability analysis concluded that the degree of any slope stabilisation required is dependent on the angle of newly created slopes. Assessment has shown that a slope angle of 34° is deemed to be what the strata will naturally attain if left exposed. This is the steepest angle slope permitted to require the minimum protection measures. An angle of 60° is considered the steepest angle at which the slope may be safety stabilised for long term integrity. The Slope Stability Assessment undertaken may be found as Technical Appendix 13-2.

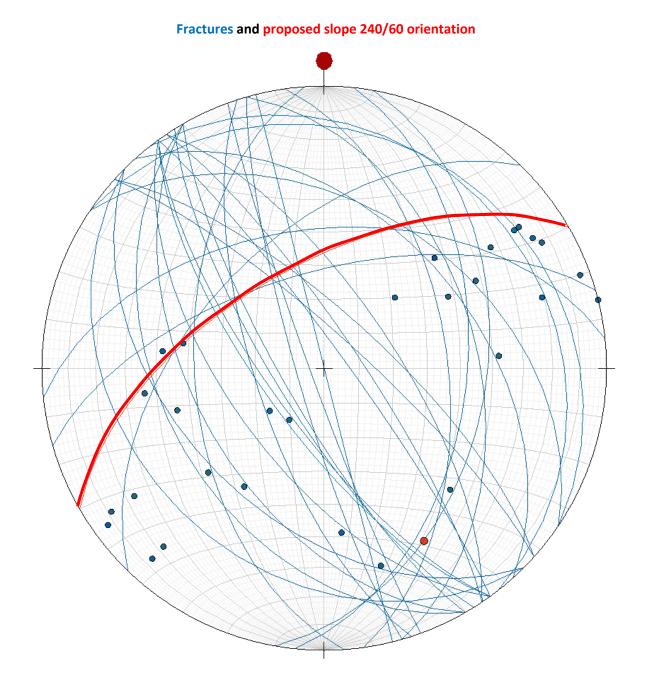
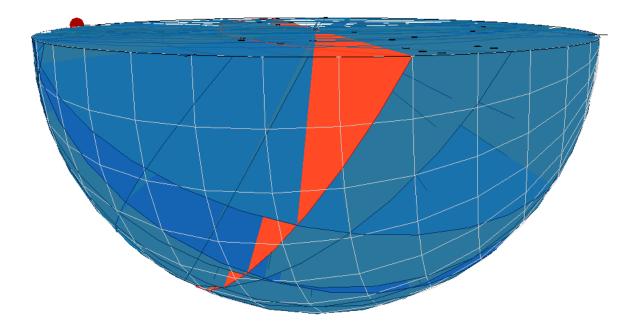
Bedding, Fractures and proposed slope 240/60 orientation
